BERRY RESERVOIR DAM
CT 00130

PHASE I INSPECTION REPORT
DAM INSPECTION PROGRAM

JANUARY 1980

4. TITLE (and Subtitle) Mulberry Reservoir Dam NATIONAL PROGRAM FOR INSPECTION OF NON-FEDERAL DAMS		5. TYPE OF REPORT & PERIOD COVERED INSPECTION REPORT

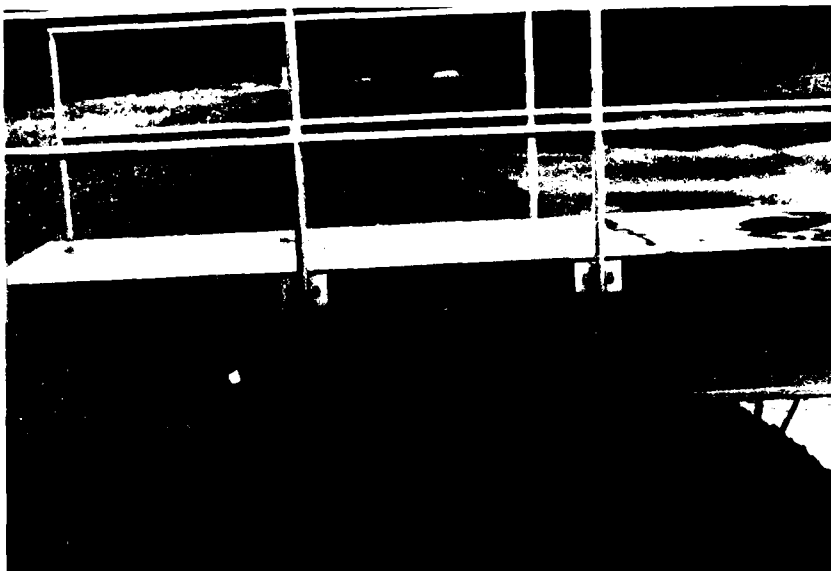
PHOTO NO. 5

The bridge to the gatehouse is generally in good condition, except for a transverse crack at the second pier from the dam, Photo 5. The visible part of the gatehouse structure is in good condition.

GATEHOUSE BRIDGE PIER
TRANSVERSE CRACK IN PIER SUPPORTING STEEL BEAM
